## MINNESOTA ARCHITECTURE-HISTORY INVENTORY FORM

Property Location			
<b>Property Name:</b>	R. Welch Building	<b>Inventory No.</b>	ME-LTC-0019
<b>Address:</b>	19 East Depot Street	<b>County:</b>	Meeker
<b>City/Twp:</b>	Litchfield	<b>PIN</b>	27-0826000
<b>T-R-S Quarter:</b>	T119N R31W Sec. 11 SW ¼	<b>Block:</b>	65
<b>USGS Quad</b>	Litchfield North, Minnesota	<b>Lot:</b>	Partial 19 and 20

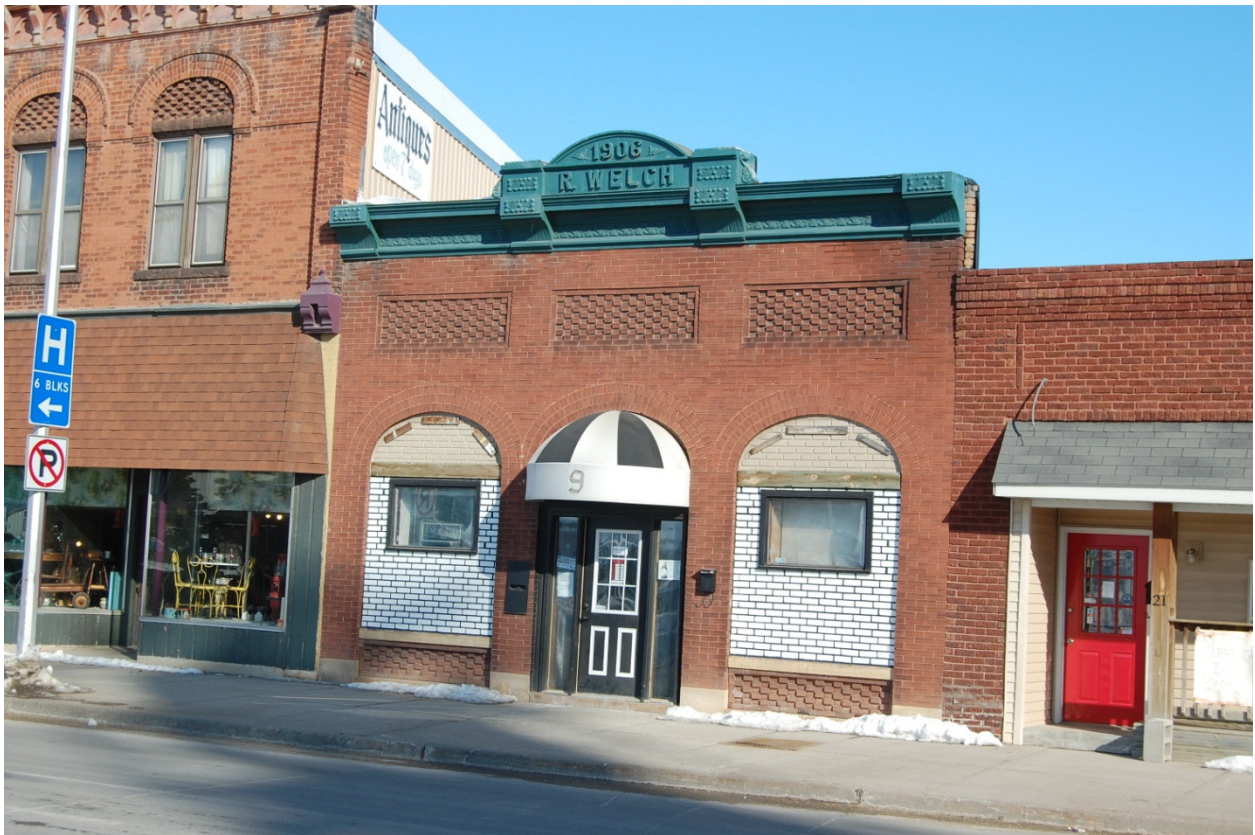
Facing N

The R. Welch Building is a small, one-story building faced with reddish-brown brick. It was designed in a commercial version of the Queen Anne style. At the top of the building is an ornate metal cornice with egg and dart molding. There is lettering in the cornice that reads "R. Welch 1906." The three-bay main façade has rounded arched window and center door openings. Above these openings are three rectangular panels of checkerboard brickwork. The window and door openings have been infilled with brick and smaller window units.

The condition assessment noted that repointing was needed near the top of the façade, and there is some minor deterioration of the stone base. Bowing of the brick pilaster west of the entrance has been addressed by the use of a metal plate to pull it in.
