MINNESOTA ARCHITECTURE-HISTORY INVENTORY FORM

Property Location			
Property Name:	Black and White Inn	Inventory No.	ME-LTC-0196
Address:	311 Sibley Avenue North	County:	Meeker
City/Twp:	Litchfield	PIN	27-0677000
T-R-S Quarter:	T119N R31W Sec. 11 SW ¼	Block:	52
USGS Quad	Litchfield North, Minnesota	Lot:	18

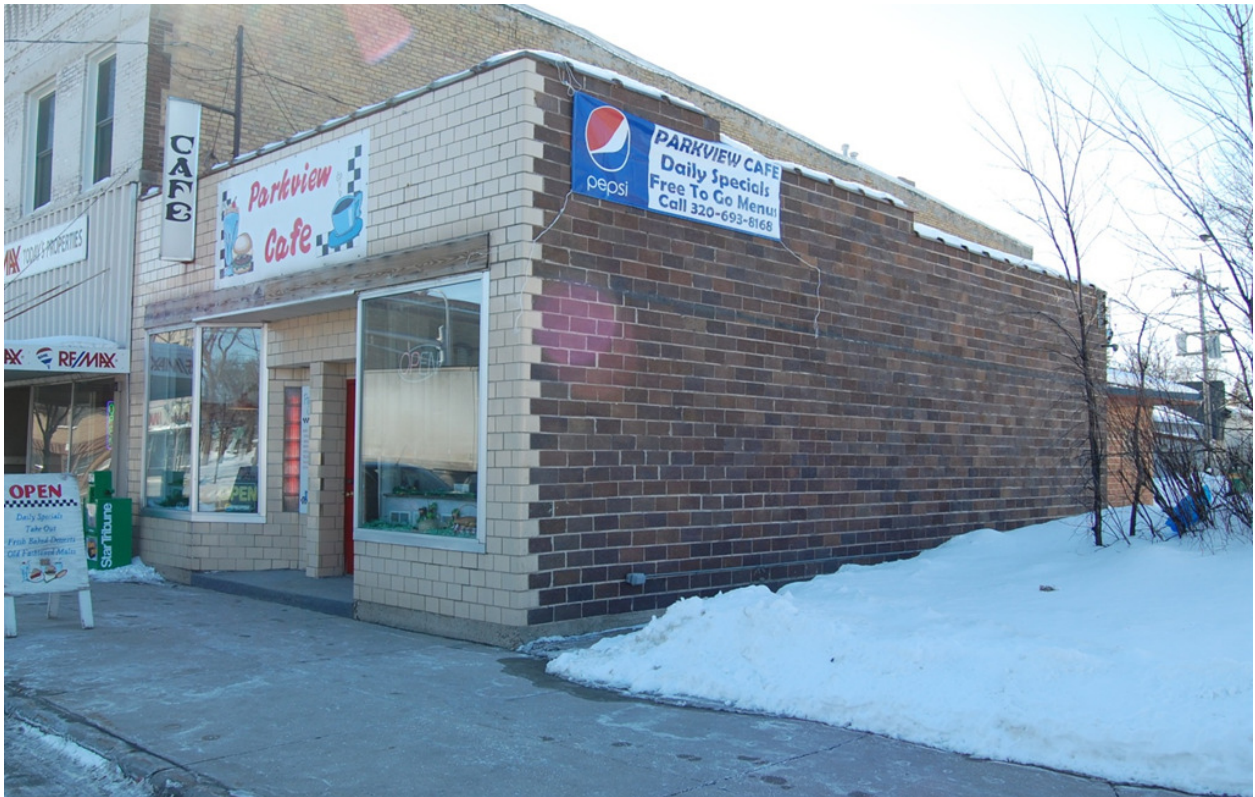
Facing SW

This is a small one story building faced with glazed yellow ceramic tile. It is built of hollow clay tile and has a flat roof. The storefront has restrained Moderne features such as glass block at the entrance and window surrounds framed in metal. The building originally offered two storefronts, with paired, recessed entries at the center. A shed roof, clay-tile wing extends from the rear.

The small building remains largely intact, and exhibits its modest Art Moderne style. Minor alterations have occurred, including changes to the paired store entries and doors, and the removal of the retractable canvas awning (leaving an unpainted board in its place).

This building is in good condition. Minor tuck pointing is necessary in some locations.
